A Red Light Running (RLR) Photo Enforcement System was installed at the intersection of Illinois Avenue at Plum Grove Road on May 1, 2008 (northbound), after finding limited success with other attempted measures to promote safer driving and improve compliance with traffic laws. As a condition of use, both Illinois law and the Illinois Department of Transportation require periodic statistical analyses/evaluations be conducted.

## Illinois Avenue at Plum Grove Road Palatine, IL

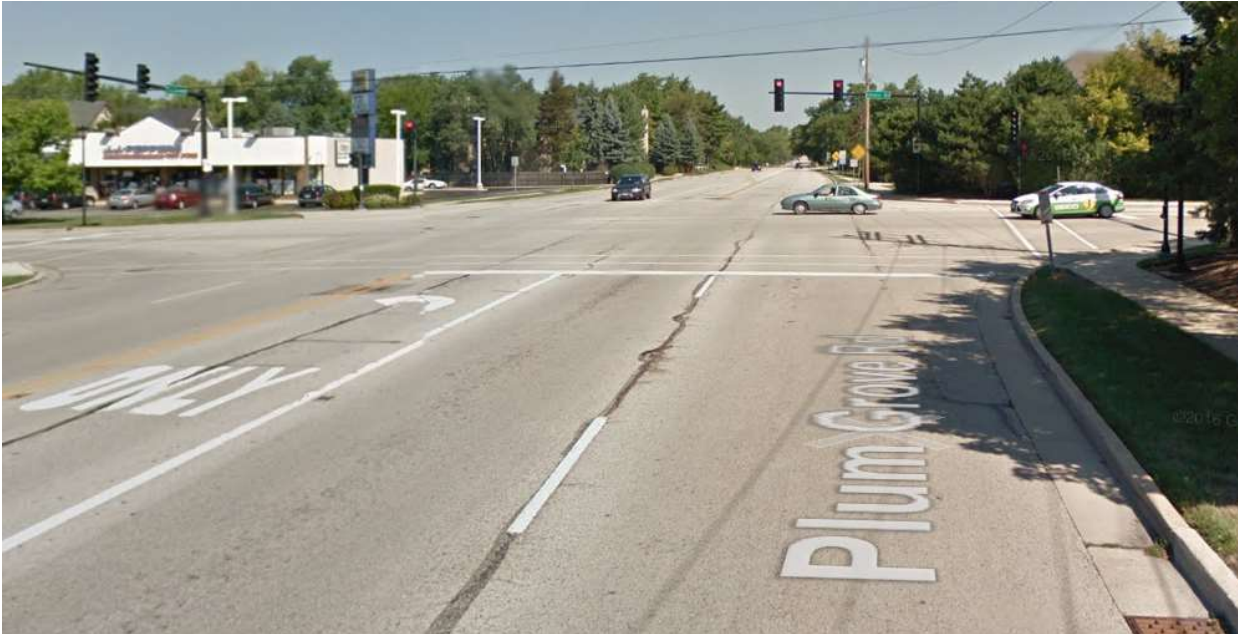
**Illinois Avenue at Plum Grove Road, Northbound Approach**

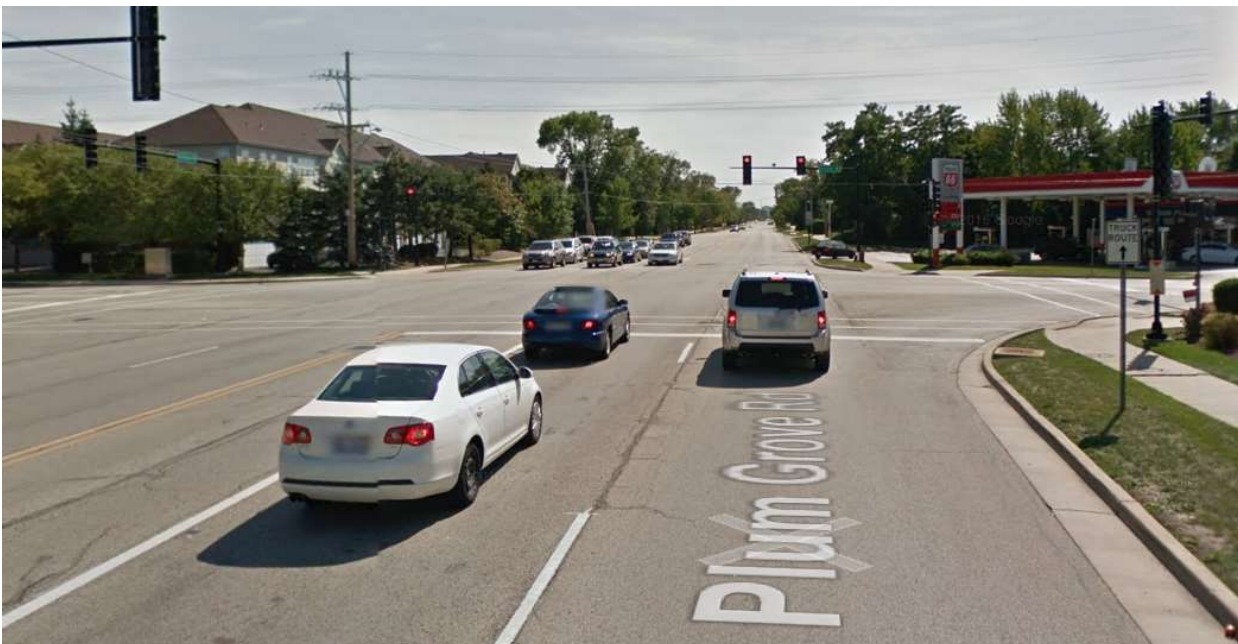
**Illinois Avenue at Plum Grove Road, Southbound Approach**

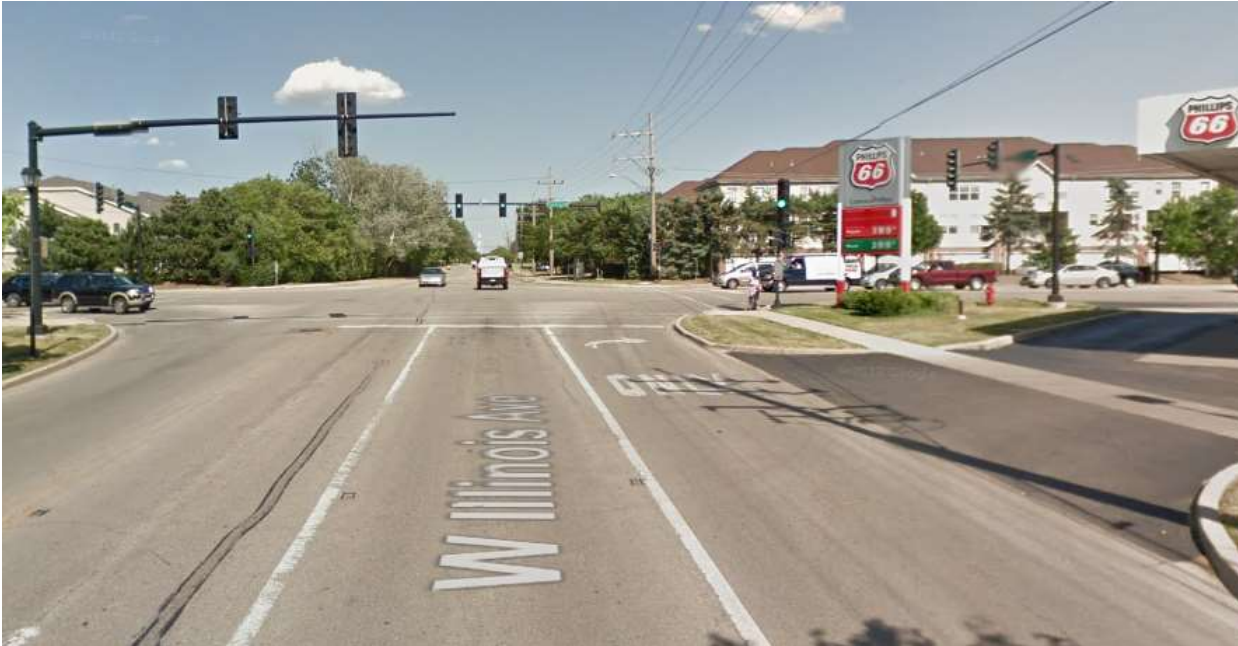
**Illinois Avenue at Plum Grove Road, Eastbound Approach**

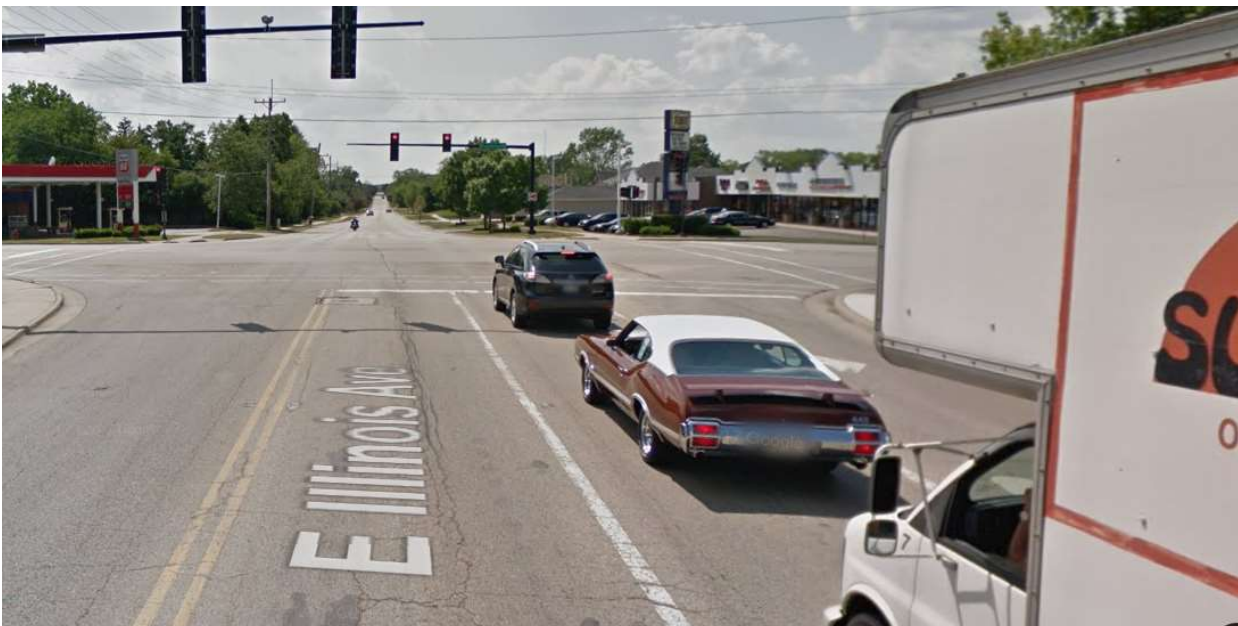
**Illinois Avenue at Plum Grove Road, Westbound Approach**
